**TIPPERARY HISTORICAL JOURNAL
1988**

SOME PRELIMINARY NOTES ON THE EXCAVATION OF DOLLA CHURCH, KILBOY, CO. TIPPERARY

Etienne Rynne

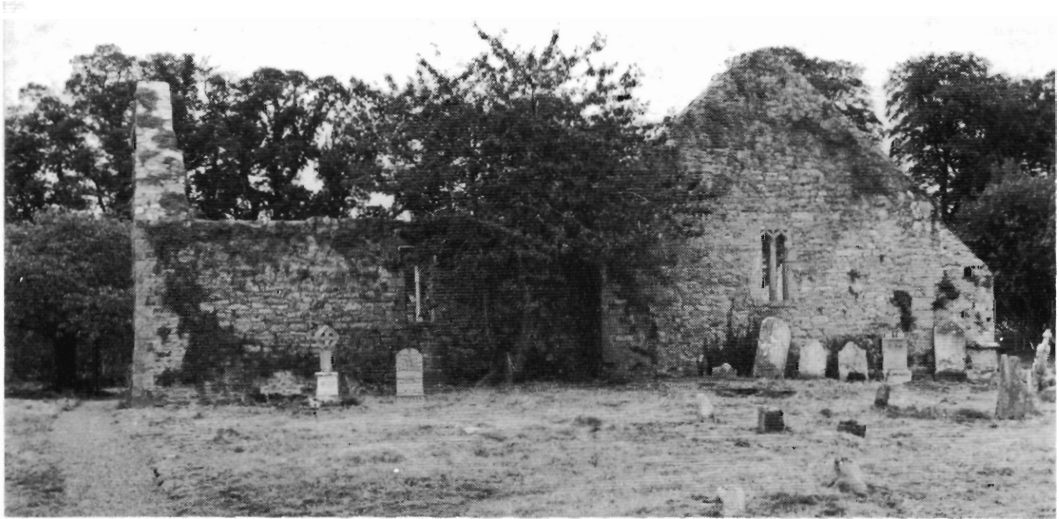
Fig. 1 Dolla Church from East, as seen from the gateway entrance to the graveyard.

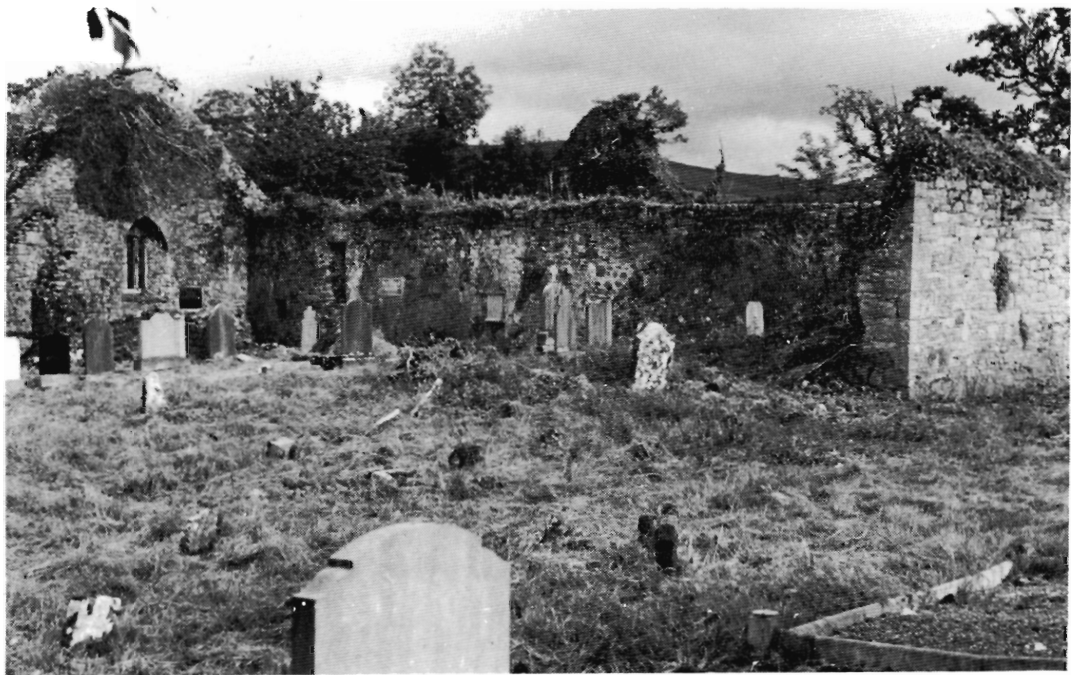
Fig. 3 Dolla Church from North-West before cleaning and reconstruction.

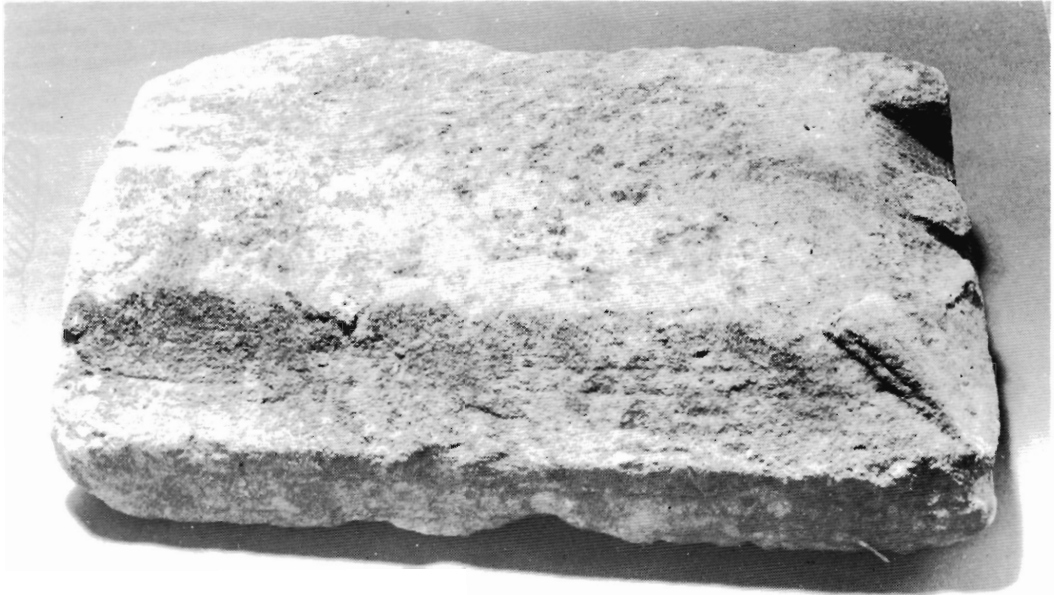
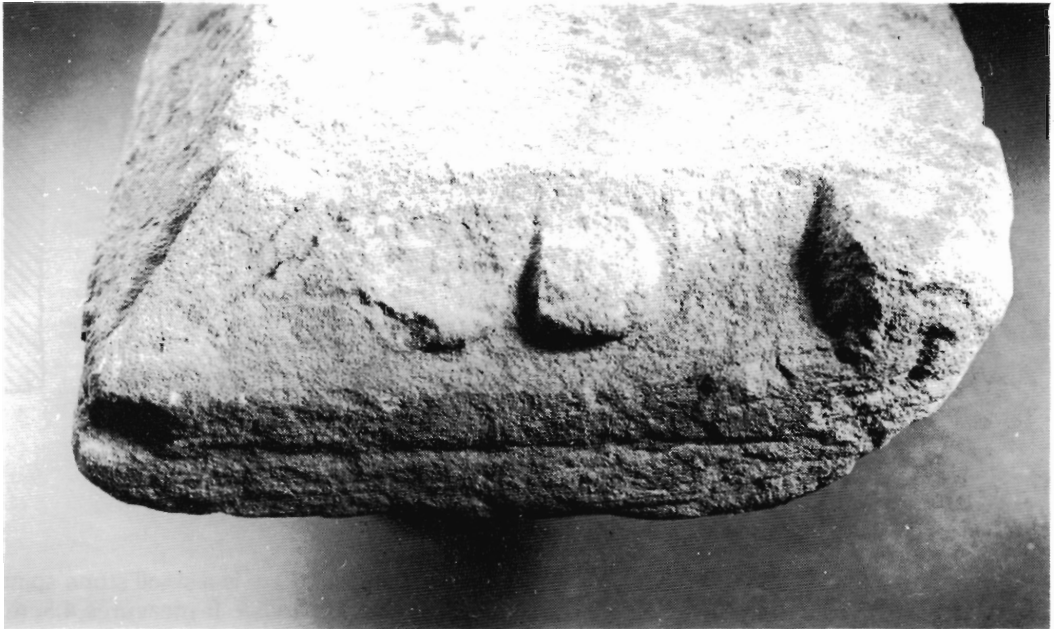
Fig. 6 Two views (from the under side) of carved stone of probable late 12th or early 13th century date.

have been removed to be replaced by the late 15th century building — other apparent evidence for this are some stones which have diagonal axe-dressing characteristic of the 12th and 13th centuries which were found loose in the graveyard or incorporated with the present buildings. Also found was a similarly dressed and finely carved stone (Fig. 6) which had the appearance of an abacus or impost from a late 12th or early 13th century doorway — an apparently similar but somewhat damaged stone is to be seen in the rebuilt (19th century) uppermost portion of the south-eastern corner of the church.

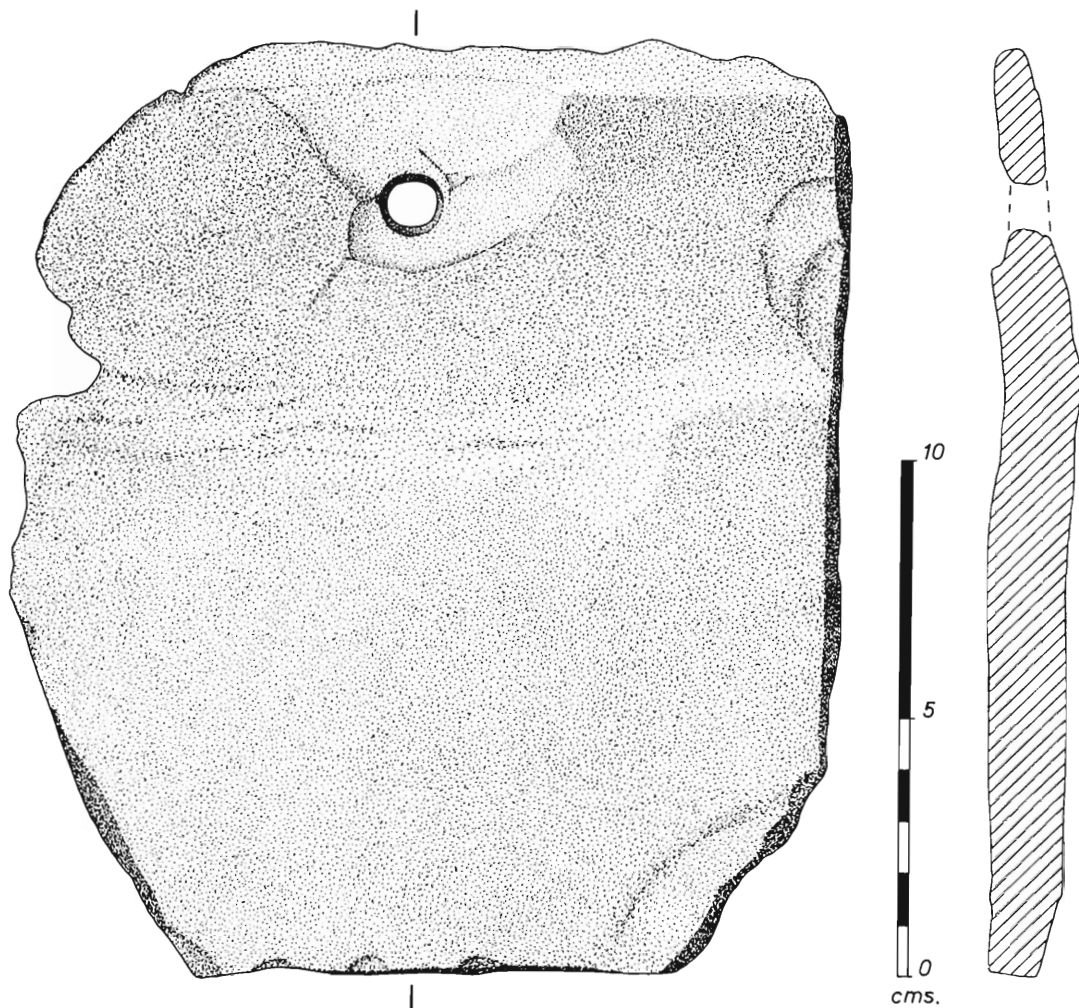
Fig. 7 Roof-slate from Dolla Church.

Apart from some bones, iron nails and portions of wood and mountings from old coffins, several roof-slates, some with nail-holes, were discovered. Fig. 7 illustrates a good specimen: roughly square in shape, it measures 18cm. in length by 16cm. in width and is up to 2cm. in thickness, the perforation being 8mm. in diameter. It has been inspected by Dr. Michael Williams of the Department of Geology, University College, Galway, who believes that it is “Not ‘slate’ since cleavage planes are too poorly defined. Interbedded sandstone/siltstone possibly from the turbidite facies of local Silurian sequence of the Slieve Bernagh, or hills to the South of Nenagh”.
