**TIPPERARY HISTORICAL JOURNAL
1994**

Late Medieval Structures in Clonmel: Further Remarks

By Patrick Holland

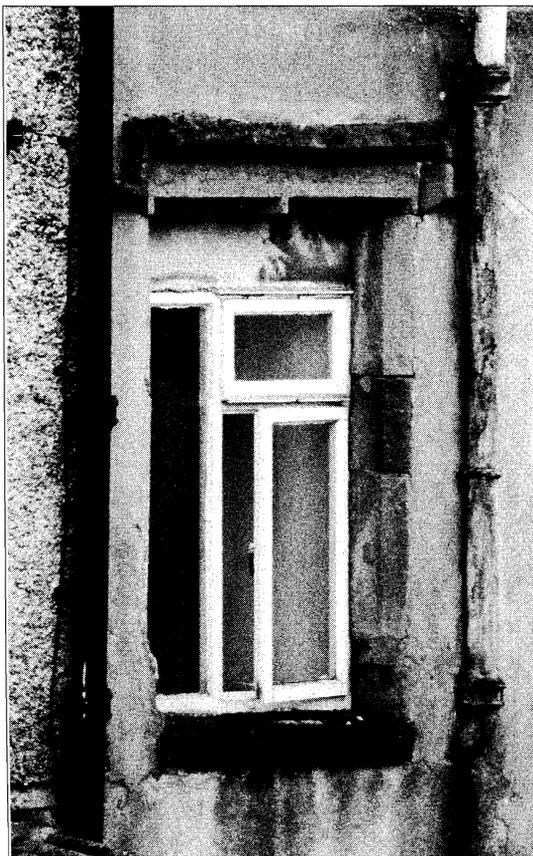
In the rear wall, and visible from the car-park at the rear of Brady's shopping mall, is a tall window (Plate 1) with hood moulding, facing outwards and northwards. Some of the sandstone jambs are visible on the eastern side. This fragment adds further archaeological evidence for the existence of secular late medieval dwellings in Clonmel.

Plate 1 – window in the rear wall of 57 O'Connell St., Clonmel.
